PHENIX WEEKLY PLANNING

11/29/12 Don Lynch

Last Week & This Week

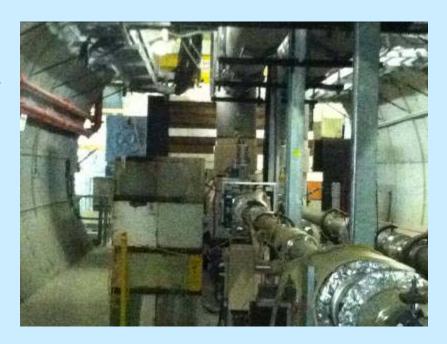
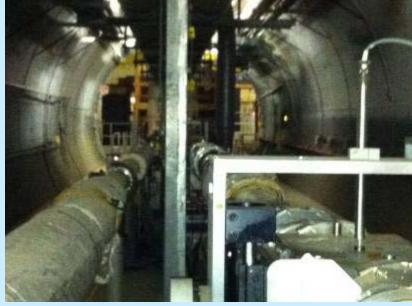
Looking towards RPC3 South

Large shielding modifications at Q2 upstream north and south to be planned and installed by CA-D (Dave Phillips) by 12/14/2012. In progress this week

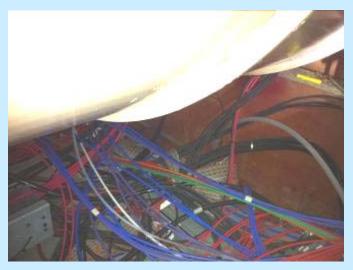
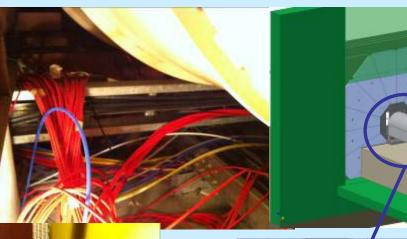
Under DX at RPC3 North

← East West → Under DX at RPC3 South ← West East \rightarrow

144 Steel bricks, 2x4x8, stacked in 3 high, 16 wide, 3 rows, respectively by 11/21

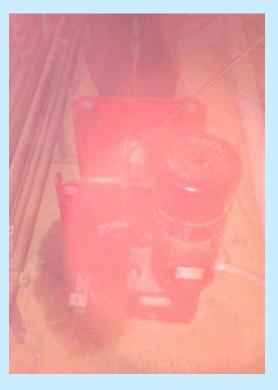
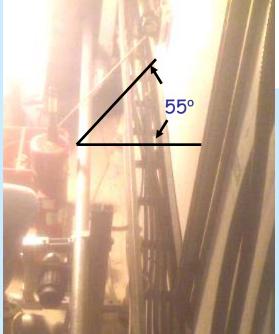
Window Washer Remote Pin Removal and Winch/spooler safety upgrades

Space available: 16.5" x 27" x 28" h

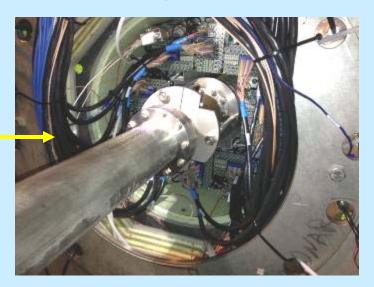
Proposed vacuum bellows anti-squirm
In MPC S Cavity to accommodate MPC-Ex

MPCS Flat cables replaced with round cables.

Z-AXIS EXTENSION RAILS X-AXIS RAILS RAIL SUPPORT
